Replace the drain in the tub

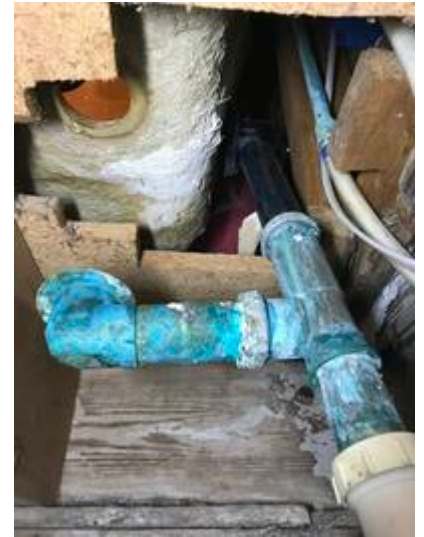
During [tub stopper](#), drain broke away and was found to be heavily corroded. Replacing with a plastic kit.

- ~~Remove the old drain completely.~~
- ~~Cut less than half an inch off both elbows.~~
- Follow the instructions on the kit to replace the drain.

The overflow is slightly misaligned and the quality of the drain is poor but all functions without leaks. The old drain T was found to be in good shape. Only the screw in part of the drain was broken.
